Gravel Built Up Coatings Restoration Case Study

This case study shows what a typical gravel built up roof looks like when it is twelve to fifteen years old and then after a Polyurethane Foam and the WeatherStar Coating System have been installed.

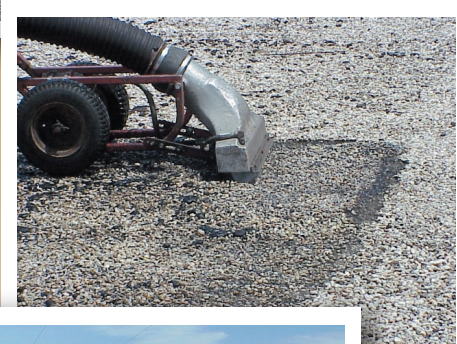
The AWS approved Dealer first takes off all the loose gravel on the roof and thoroughly cleans the substrate. In this case he accomplishes both by wet-vacuuming the roof. This ensures the polyurethane foam will adhere to the existing roof substrate. We always recommend a moisture survey before installing foam to ensure a successful job. If moisture is found in existing roofing system, the contractor will remove wet areas before installing polyurethane foam.

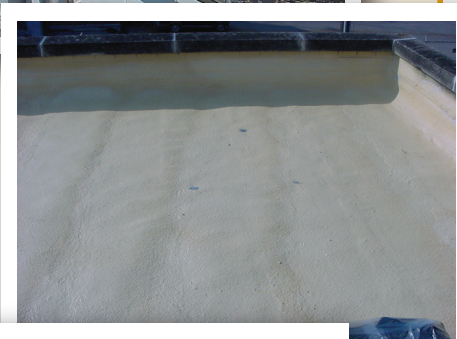
After the foam is installed, in order to protect the foam from the sun's ultraviolet rays, the Dealer applies two coats of a WeatherStar top-coat. Options include Acrylic 211 on roofs with a positive draining slope and on flat roofs that don't drain water well, we recommend either the Urethane 520 or Silicone 410. Without the coating, the foam would quickly break down under UV rays.

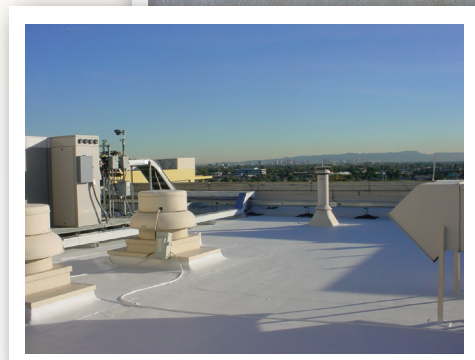
The WeatherStar Foam and Coatings system not only gives the building owner an outstanding waterproof solution, it also adds an R10 insulation value for his building. (Foam sprayed at 1.5")
